**Marine Corps Systems Command
Combat Support Logistics Equipment and Training
Systems Directorate
Quantico, VA 22134-5010**

August 1999

**Summary of Developmental Testing for the Light
Strike Vehicle / Internally Transportable Vehicle
Program**

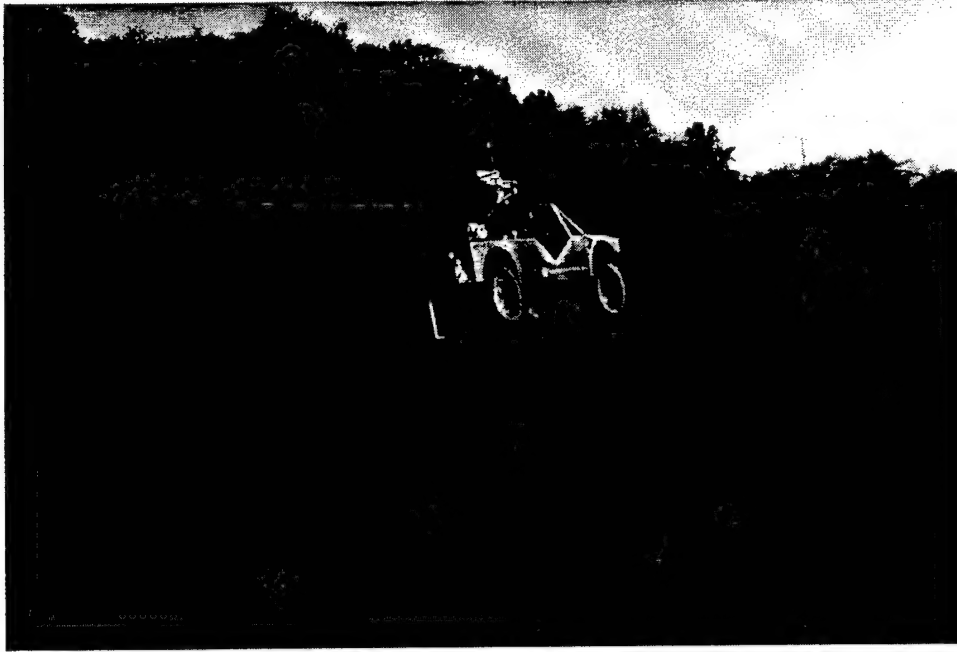
Figure 4. Rear view of HTTV transitioning from gate 2 to gate 3 of the TOP lane change course.

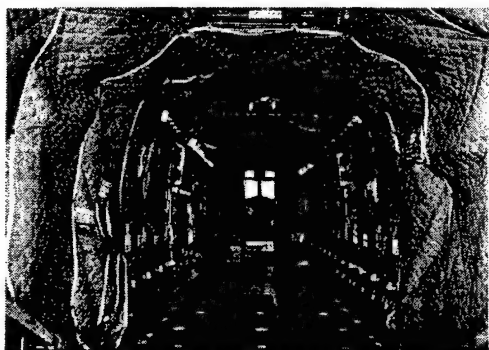
PSD 24265-06-96-31A, V-22 FSD Cargo area

A/C-2 was a flying, full scale demonstrator. For the JTEV and notional RSTA-V fit checks it was modified to match the current engineering, manufacturing development (EMD) version of the aircraft. To simulate the EMD version, four troop seats were installed. A total of 25 troop seats will be fitted to the production aircraft arranged along each side facing inboard, 12 port and 13 starboard. Insulation and sound proofing were installed in the cargo area by means of aircraft thermal blankets. The thermal blankets are evident in *Photograph nr. PSD 24265-06-96-31A*.

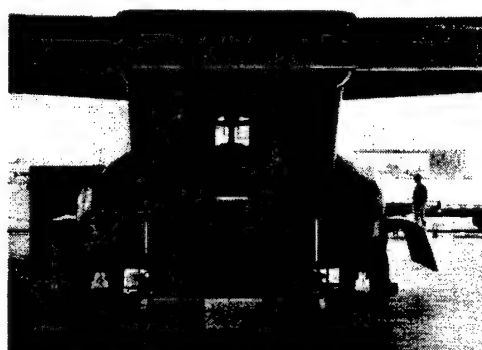
PSD 24265-06-96-28A, V-22 FSD ramp

A/C-2 was originally configured with a single loading ramp. The single piece ramp was removed and the bottom split ramp installed as in the future EMD aircraft. The actual short flipper ramps were not available, so wooden ramp extensions were constructed to simulate the flippers. The aircraft ramp angle was measured at 11.3 degrees and the wooden extensions had an angle of 14.4 degrees. The maximum ramp angle will be 18.5 degrees, as limited by the stroke of the ramp actuators. The cargo bay deck was parallel to the ground plane (measured at 0 degrees). The ramp configuration for the test can be seen in *Photograph nr. PSD 24265-06-96-28A*.

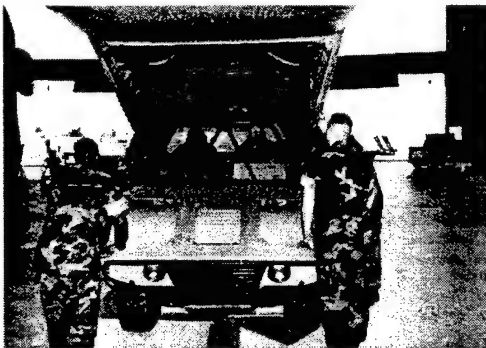
PSD 24263-06-96-11A, JTEV Backing in

The JTEV was driven into and out of the V-22 forward and backward at low and high ride heights with and without the 50 caliber, M-2 machine gun mounted. Each configuration was tested several times. USMC aircrewmembers monitored the clearance of each corner of the vehicle as it entered and exited the aircraft, *Photograph nr. PSD 24263-06-96-11A*. Clearances between the wheels and buffer boards, rollcage and ceiling, and gun and ceiling were checked and recorded by taking photographs of tape measures held in place to illustrate clearances.

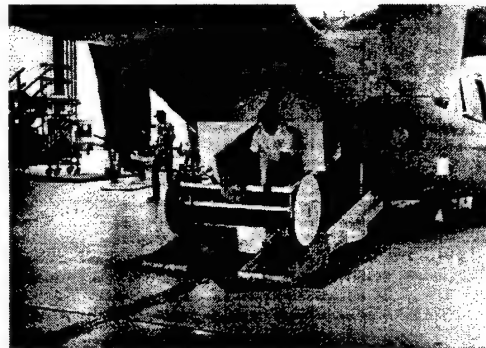
PSD 24259-06-96-33, RSTA-V model exiting

Next the RSTA-V model was assembled and rolled in and out of the V-22, *Photograph nr. PSD-24259-06-96-33*. This was done forward and backward. The adjustable panels on the front profile templates were mounted 64 inches from the ground. At this height it was known that there would be interference between the model and the inside of the aircraft. Triangular pieces of the outer corners of these adjustable panels were trimmed to eliminate interference with the interior of the aircraft. This was done until the model rolled in and out of the aircraft with no interference. The final dimensions of the triangles that were removed were approximately 4 by 6 inches, *Photograph nrs. PSD 24259-06-96-14 and -15*. The 4 and 6 inch dimensions were oriented vertically and horizontally respectively. This exercise was utilized to determine the maximum vehicle envelope.

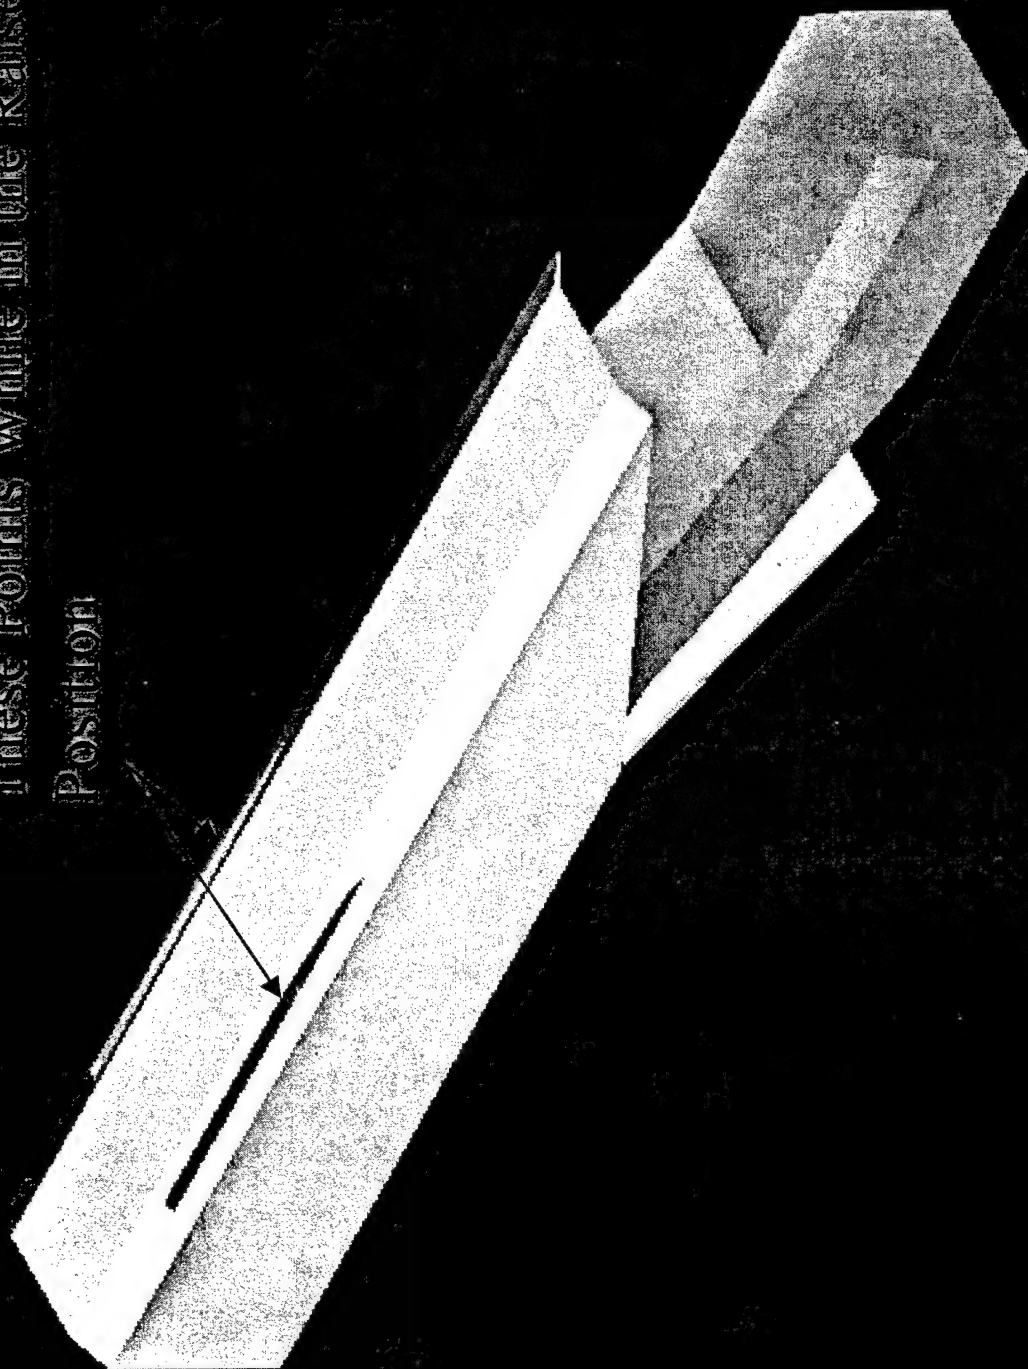
Units are in inches, pounds, and inch-pounds.

MTV Violates Cargo Bay Shape and
These Points While in the Raised
Position
